Ka 2 u. Ka 2B . . . . .	TN-No. 11
Ka 6, 6/0, 6B, 6BR, 6CR, 6B-S . .	TN-No. 21
K7 . . . . .	TN-No. 18
K8, K 8B, K 8C . . . . .	TN-No. 23
K9 . . . . .	TN-No. 1
K11 . . . . .	TN-No. 1
ASK 13 . . . . .	TN-No. 12
ASK 18, ASK 18B . . . . .	TN-No. 6

Subject: Elevator.

Technical Note  
for  
Glider Models as per Sheet 1

Alexander Schleicher  
GmbH & Co.  
Segelflugzeugbau  
D-6416 Poppenhausen

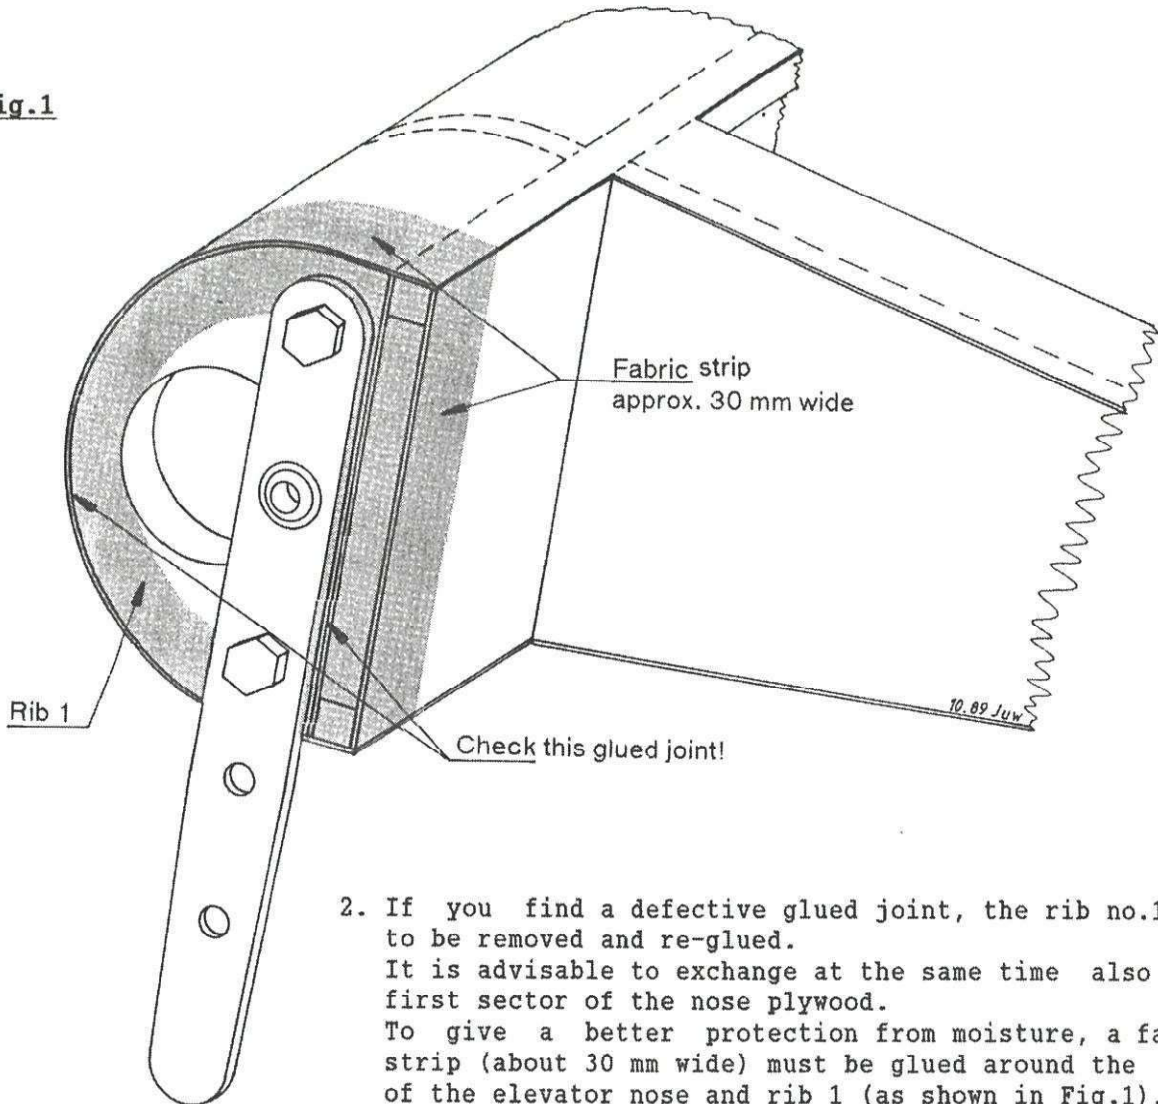
Fig.1

Reason: A glider of the model K7 failed to gain normal flight attitude immediately after tow rope release on winch launch. With the stick full back only the left elevator could be actuated in the correct direction; the right elevator deflected downwards. The reason for this was a loose glue bond at the elevator rib 1 at which the elevator fitting is attached. Similar incidents lead already before to the issue of the LTA 72-7 dated Feb.9,1972.

1. Remove elevator.  
Check that the glued joint between rib 1 and the leading edge plywood and the elevator spar respectively is in good condition (see Fig.1). Before doing so check whether the LTA 72-7 of Feb.9, 1972 was already previously accomplished (this is not applicable to K9, K11 and ASK 18); if yes then the fabric strip first carefully has to be detached in order to be able to check the glued joint.

- 
2. If you find a defective glued joint, the rib no.1 has to be removed and re-glued.  
It is advisable to exchange at the same time also the first sector of the nose plywood.  
To give a better protection from moisture, a fabric strip (about 30 mm wide) must be glued around the edge of the elevator nose and rib 1 (as shown in Fig.1).
3. The above action under points 1. and 2. must be repeated every three years during the annual re-inspection.  
This copy of the Technical Note must be inserted in the Flight and Operations Manual of the respective glider as an annex and a corresponding entry must be made into the "Amendments to the Manual".
